MICROSTRUCTURE-BASED FATIGUE LIFE PREDICTION METHODS FOR NAVAL STEEL STRUCTURES

K. S. Chan
D. L. Davidson
R. C. McClung

FIRST ANNUAL REPORT
July 15, 1991-July 15, 1992
SwRI Project No. 06-4414
ONR Contract No. N00014-91-C-0214

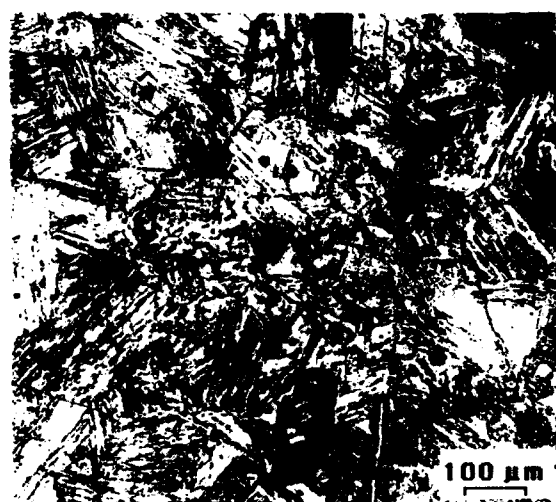
Figure 3. Microstructures of materials tested in fatigue. (a) as-received, sp. 353, (b) HT#2, sp. 357, (c) HT#3, sp. 358, and (d) weld, sp. 359.

The microstructures of both the as-received and heat-treated materials were characterized by optical and transmission electron microscopies. Optical micrographs of the HSLA steel in the as-received, heat-treated (HT#2), heat-treated and aged (HT#3), and weld materials are presented in Figure 3, respectively. The as-received microstructure consisted mostly of fine polygonal and accicular ferrite grains with sulfide inclusions. The heat-treated materials exhibited a lath-like microstructure, which is similar to those observed in modified A710 and HSLA 100 steels. The weld microstructure, shown in Figure 3(d), appeared to contain coarse ferrite grains and small particles embedded within the ferrite grains. The nature of these embedded particles had not been identified.

In the as-received microstructure (Lehigh material), Figure 3(a), cracks initiated from inclusions in almost every incidence. The size of the inclusions and their frequency of occurrence are shown in Figure 10, which is the result of the analysis of 86 inclusions. Inclusion size thus provides a lower limit to the smallest size of a crack that may be studied in this microstructure.

If the microstructure contained lath-like features, Figures 3(b) -(d), cracks no longer initiated at inclusions, but along the lath-like features instead. This shift in initiation site is illustrated in Figure 13. All parts of this illustration are at the same magnification, so it is possible to directly see the relationship between microstructural feature size and crack size near to the point of crack initiation.
